Diyala Journal of Engineering Sciences

EVALUATING THE CONNECTION AREAS BETWEEN BRICKS WALLS AND CONCRETE COLUMNS IN CONFINED MASONRY BUILDINGS IN IRAQ

Ali Fadhil Naser

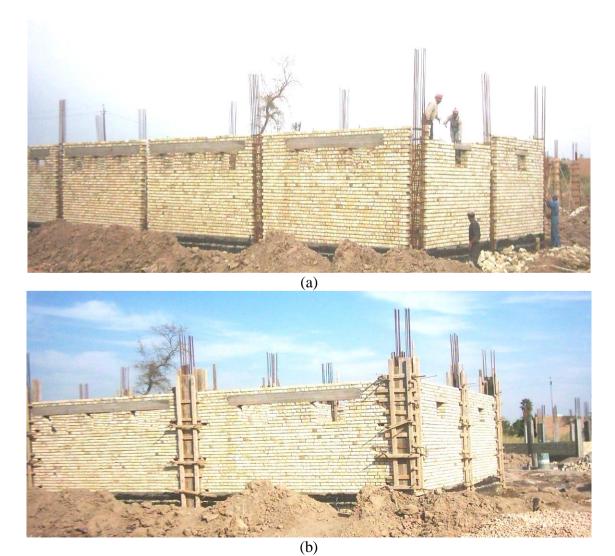
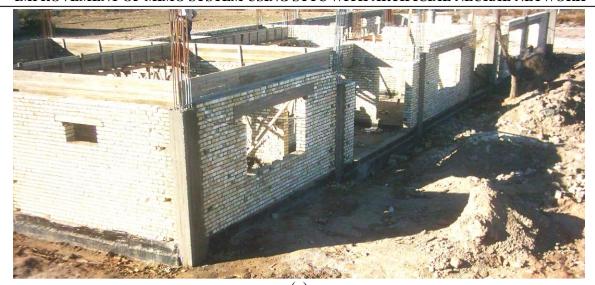
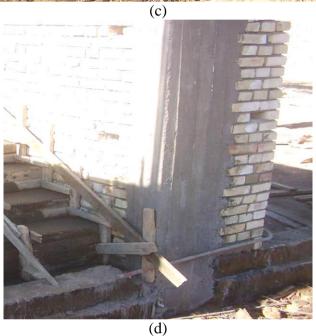
This building has two stories. The occupants of the building are employers and students. The construction method is a confined masonry by using brick wall and reinforced concrete tie-columns and tie-beams. Firstly, the brick walls were constructed then tie-columns and tie-beams were installed by using tooth edges method. Fig. (2) shows the construction method of building (A).

Fig (2): The building (A) during construction by using tooth edges connection

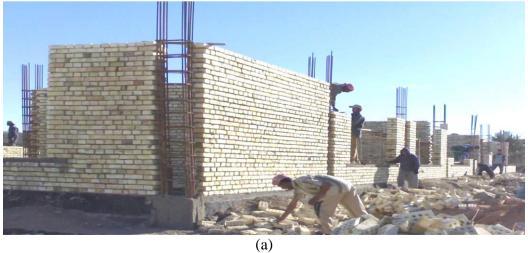
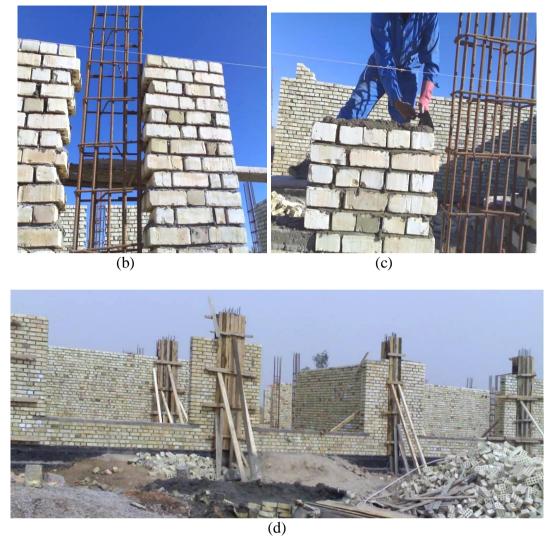
The building (D) has two stories and the students are the main occupants of this building. The method of constriction is same as building (A). It was using tooth edge method. Fig. (5) gives the construction method of building (D).

Fig (5): The building (D) was constructed by using tooth edge connection

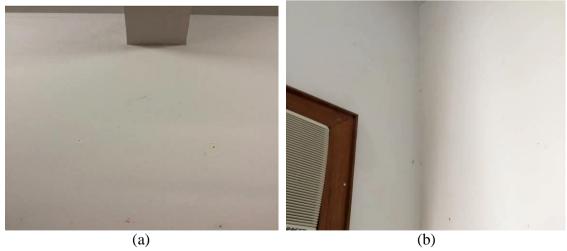
The results of damage inspection show that the building has not cracks in the area of connection between concrete columns and bricks walls because of the types of connection is tooth edge of brick. Therefore, this method did not appear cracks. Fig. (6) shows the inside building.

Fig. (6): The inside of building A.
